SR 108 MP 7.62 Unnamed Tributary to Skookum Creek: Preliminary Hydraulic Design Report

Julie Heilman PE, State Hydraulic Engineer WSDOT Headquarters Hydraulics Office

Shaun Bevan PE, Water Resources Engineer HDR Engineering, Inc.

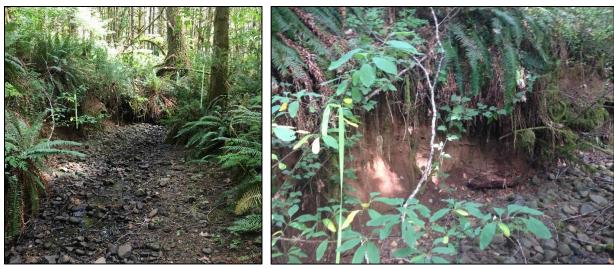
Figure 2 Typical channel (Left) and Bank erosion (Right) upstream of existing culvert

Upstream of the existing culvert, the stream corridor is densely vegetated with large trees, grasses and shrubs. The stream channel is moderately incised with more evidence of incision at the upstream extent of the survey area. Bank heights varied from 8 feet at approximately 300 feet upstream of the culvert inlet to 2 feet just upstream of the culvert inlet (Figure 2).

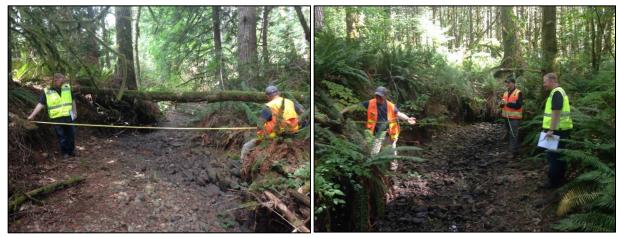
Figure 3 Bankfull width location 200 feet upstream of existing culvert (Left) and 300 feet upstream of existing culvert (Right)

Two bankfull width measurements were taken in the upstream reach, approximately 200 feet and 300 feet upstream of the existing culvert inlet, which measured 14 feet and 14.6 feet, respectively (Figure 3).

Two bankfull width measurements were taken approximately 300 feet and 200 feet upstream of the existing culvert inlet, which measured 14 feet and 14.6 feet, respectively (see photos in Section 2.0). A bankfull width measurement was not conducted in the downstream reach due to the assumed unnatural conditions.

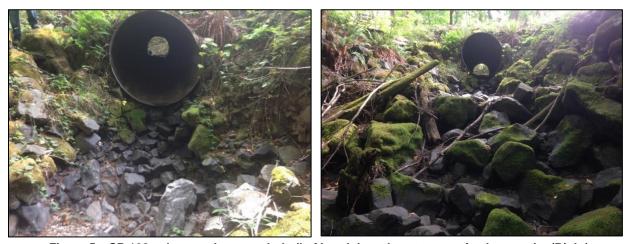
Figure 5 SR 108 culvert outlet scour hole (Left) and drop downstream of culvert outlet (Right)

There is a large scour hole downstream of the culvert outlet, creating a drop of approximately 3 feet to the assumed water surface elevation (See Figure 5). Large riprap is present in the channel bed from below the culvert outlet to approximately 20 feet downstream of the culvert outlet. At this point there is an approximate 5-foot drop from the crest of the riprap to the streambed.

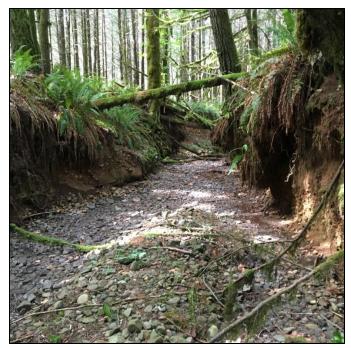
Figure 6 Typical channel in downstream reach showing bank erosion

The reach downstream of the existing culvert is highly incised with evidence of significant bank erosion and root scour (see Figure 6). The streambed has incised and armored itself with cobbles. The stream channel is nearly twice as wide as the channel upstream of the existing culvert with measurements up to 22 feet wide. The stream gradient appears to be relatively high just downstream of the culvert outlet, gradually decreases along the downstream reach, then increases again approximately 300 feet downstream of the culvert. Bank heights range from approximately 12 to 15 feet throughout the downstream reach.

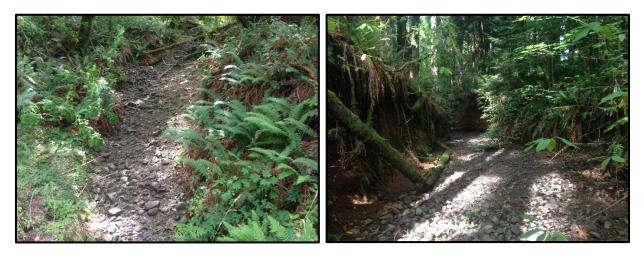
Figure 11 Typical channel upstream (Left) and downstream of SR 108 crossing (right)

The stream planform is relatively straight with mild meander bends. As no discernable flow was observed in stream at the time of the assessment, no clear riffles and pools were detected in the assessed portion of the stream. The stream gradient in the reach upstream of the SR 108 crossing is moderate, with a steeper gradient in the downstream reach (Figure 11). The stream gradient is relatively high just downstream of the culvert outlet, gradually decreases along the downstream reach, then increases again approximately 300 feet downstream of the culvert. The downstream channel is nearly twice the width of the channel upstream of the existing culvert.

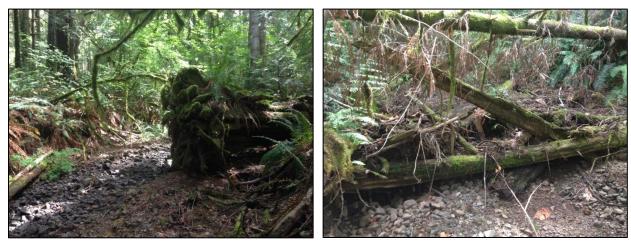
Figure 13 Typical channel upstream of existing culvert showing wood accumulation

In the stream reach upstream of the existing culvert, multiple wood accumulations were observed in the channel with high potential for wood recruitment. There is also a significant amount of wood accumulation within the downstream channel with high potential for wood recruitment due to the bank erosion. See Figure 13 and Figure 14for photos of wood accumulation in the channel.

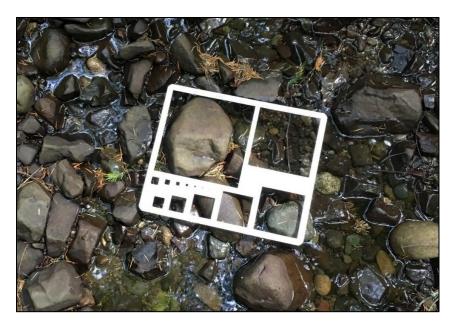
Figure 15 Streambed material photo upstream of SR 108 crossing

On August 29, 2019, three pebble count runs were performed in the reference reach, between bankfull width measurements 1 and 2. The streambed material at the pebble count location is shown in Figure 13. The grain size distribution is dominated by gravels and cobbles with a D_{50} of 2.12 inches, as summarized in Table 1. Figure 15 includes a picture of the typical substrate size observed. Figure 16 shows the cumulative distribution of sediment sizes at the location of the pebble count.

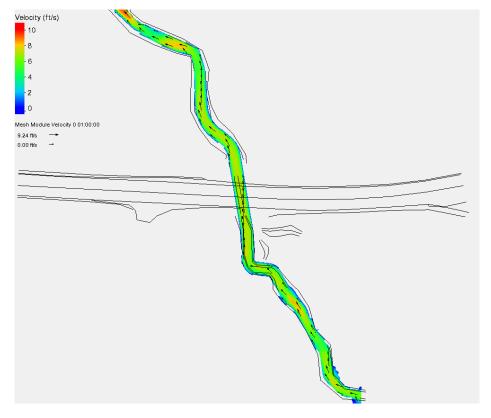
Figure 25 Proposed conditions 100-year velocity map

With the removal of the backwater condition, upstream channel velocities generally increased from existing conditions. Velocities at upstream cross sections vary from 3.6 ft/sec during the 2-year event to 6.11 ft/sec during the 500-year event. At downstream cross sections velocities vary from 3.23 to 5.79 ft/sec. Similar to the velocity results, shear generally increased upstream of the crossing, varying from 2.04 to 4.01 lb/ft². At the downstream cross section, shear values also increased from existing conditions varying at upstream cross sections from 1.85 lb/ft² to 4.01 lb/ft². The hydraulics within the proposed crossing indicate this reach is a transition from the reach upstream of the crossing to the downstream reach. Velocities, depths, and shear within the proposed crossing are all between the results of the upstream and downstream cross section. When looking at the entire model domain, proposed velocities upstream of the crossing increased compared to existing conditions. The velocity at the outlet of the crossing into the existing scour hole is decreased (Figure 25).

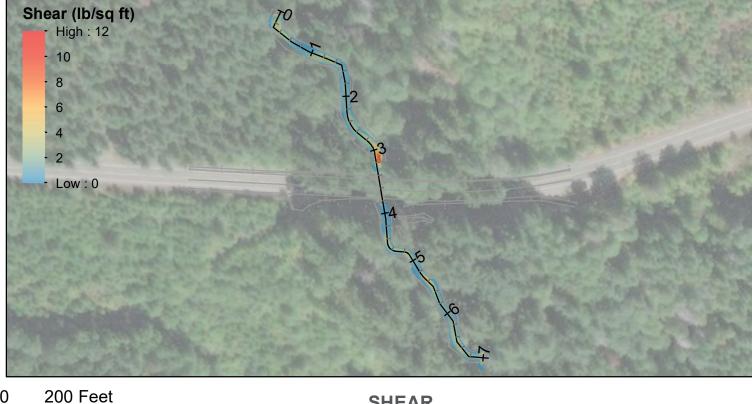
EXISTING CONDITIONS - 2 YEAR EVENT

WATER SURFACE ELEVATION

DEPTH

SHEAR

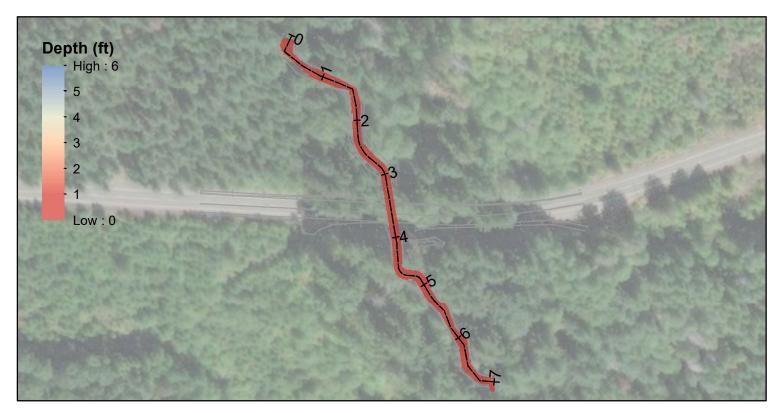
PROPOSED CONDITIONS - 2 YEAR EVENT

WATER SURFACE ELEVATION

DEPTH

SHEAR

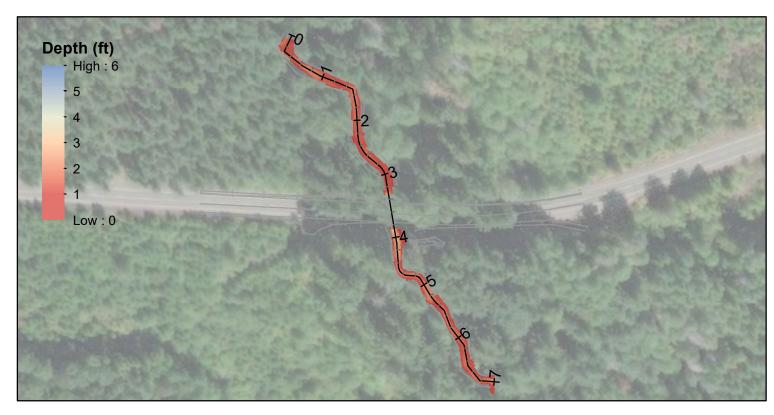
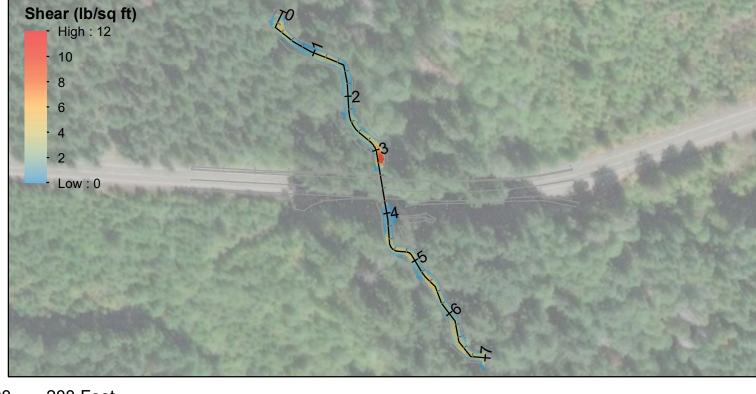
EXISTING CONDITIONS - 25 YEAR EVENT

WATER SURFACE ELEVATION

DEPTH

SHEAR

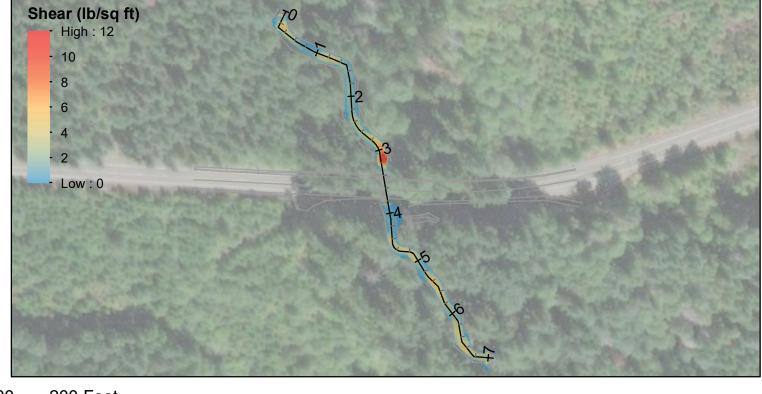
PROPOSED CONDITIONS - 50 YEAR EVENT

WATER SURFACE ELEVATION

DEPTH

SHEAR

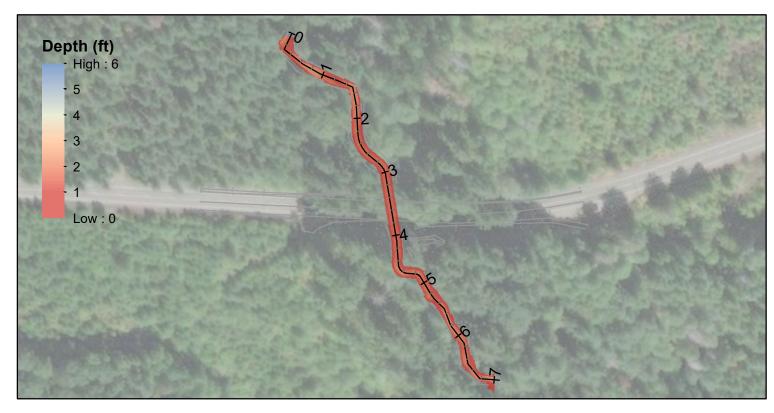
Washington State Department of Transportation **EXISTING CONDITIONS - 100 YEAR EVENT**

WATER SURFACE ELEVATION

DEPTH

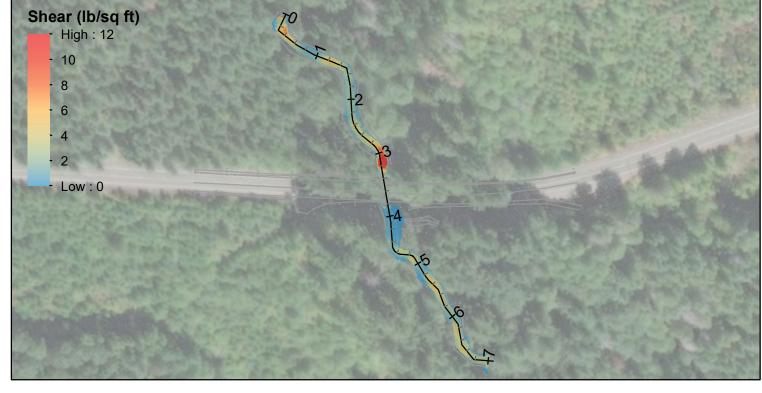
PROPOSED CONDITIONS - 100 YEAR EVENT

WATER SURFACE ELEVATION

DEPTH

SHEAR

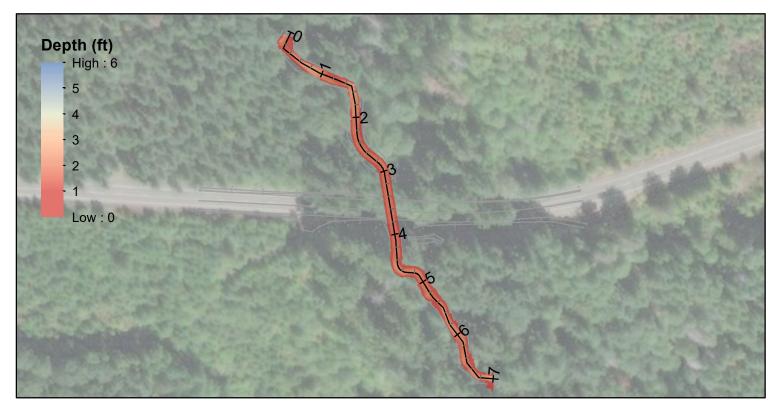
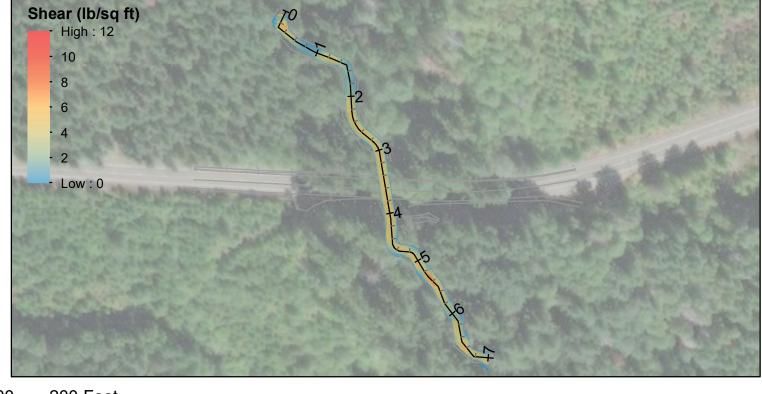
EXISTING CONDITIONS - 500 YEAR EVENT

WATER SURFACE ELEVATION

DEPTH

SHEAR
